# **Village of Bald Head Island Environmental Services Contract**

## **2023 Annual Report**

### **Bald Head Island Conservancy**

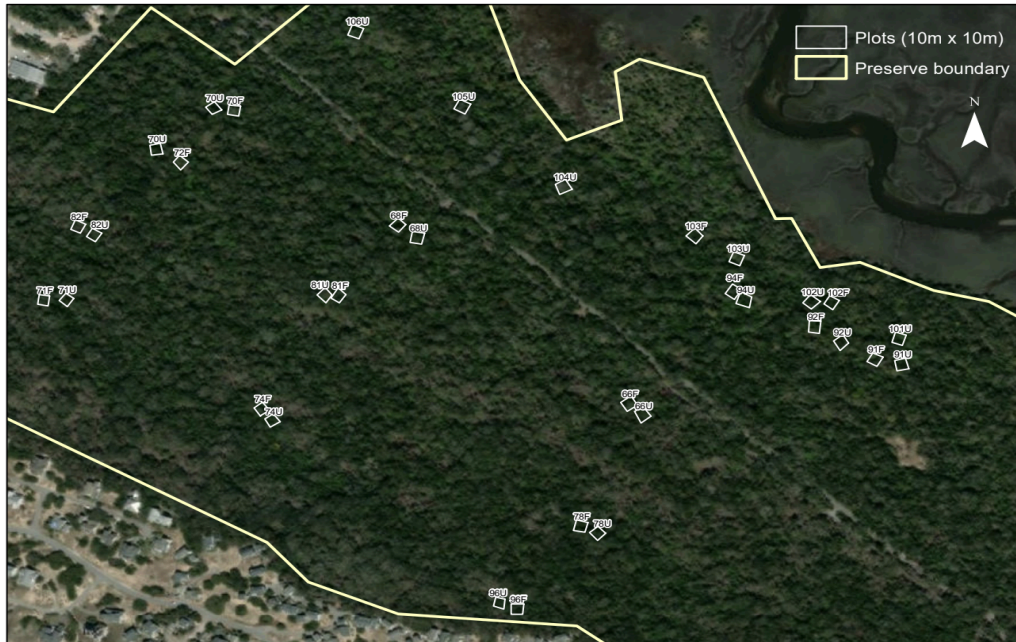
**Fig 1. Current Forest Plots**

The Bald Head Island Conservancy monitors the fenced forest plots monthly to ensure they are intact. There are currently 15 fenced monitored plots with 10 in the south woods and 5 in the north woods off of the Creek Trail (Fig. 1). Five plots have been abandoned (100, 99, 98, 97, and 101) due to being destroyed by storms or no longer being needed in the study. Monthly forest plot monitoring consists of evaluating the fencing to determine if any fixes need to be made to keep the deer out. Small holes or tears in the fencing are repaired with zip ties and overgrown vegetation is removed from the fencing with loppers. When there is a storm event, large, downed trees may need to be removed from the fencing with a chainsaw.

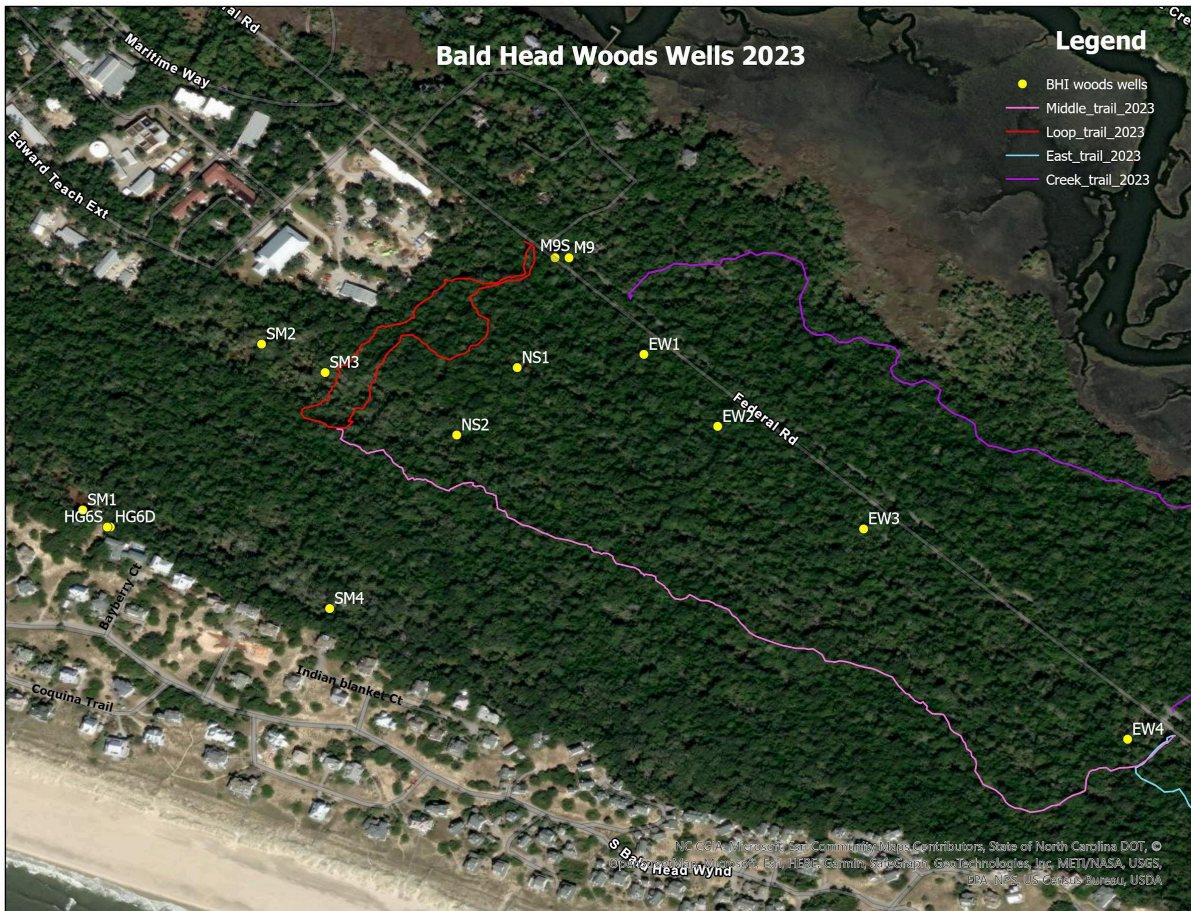
**Fig. 2.** Locations of wells associated with Bald Head Woods Coastal Reserve. “EW” wells follow an east-west transect; “NS” wells are in a north-south line. “SM” wells are within swale marshes (low-lying ponding areas). “HG” and “M” wells are in outlying areas of the Reserve.

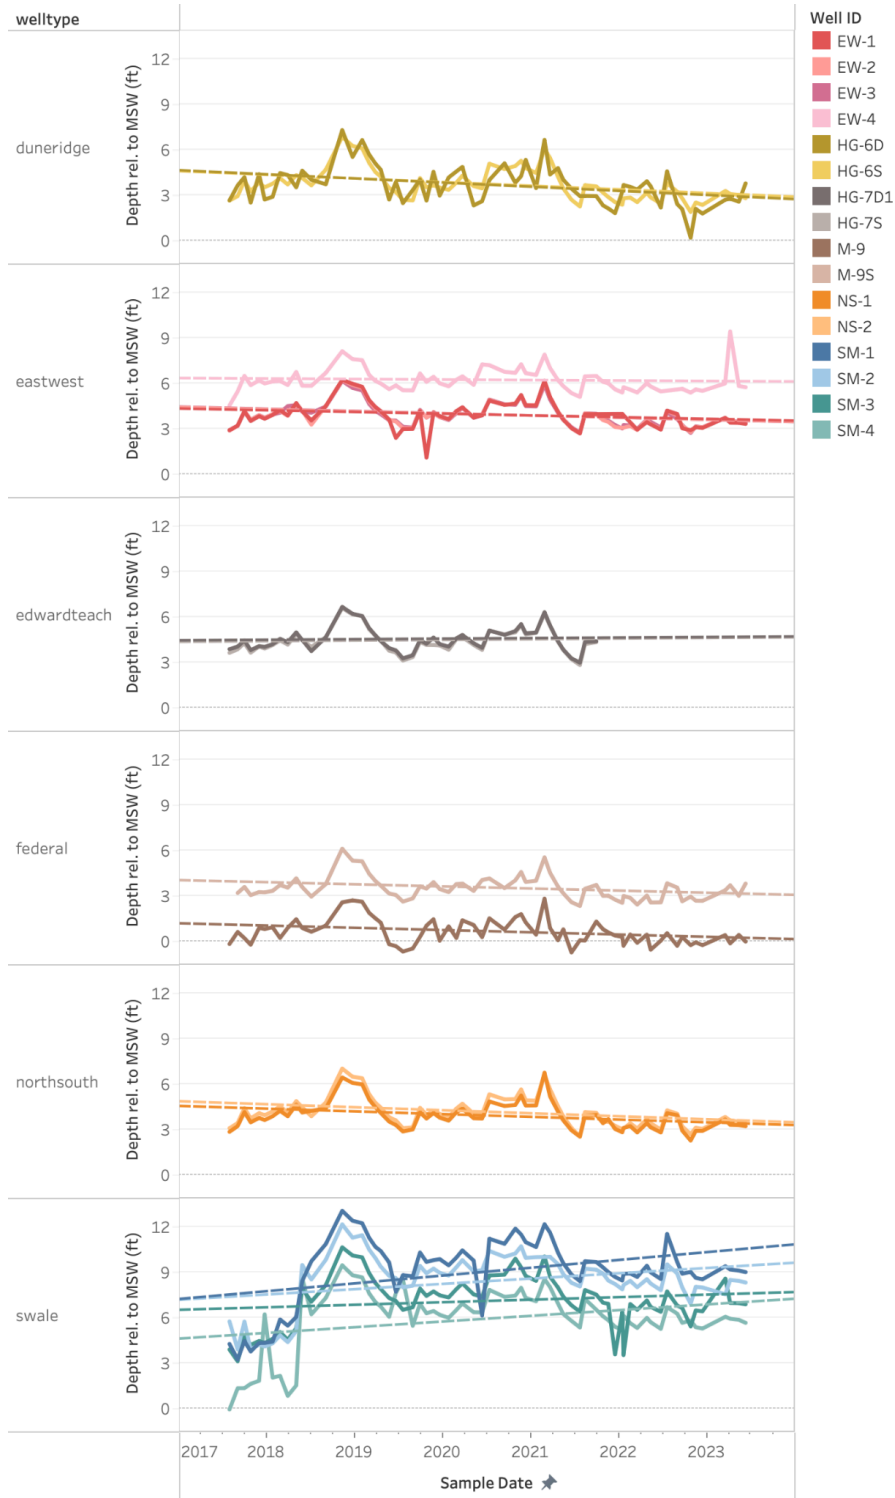
**Fig. 3.** Depth of groundwater relative to mean sea level (MSL) for each Bald Head Woods well, 2017 - 2023. Higher values represent larger aquifer volume at a particular site through time. Wells HG7D1 and HG7S were removed in 2021 due to development of the lot.

- Over the 2017-2023 time period, groundwater depth relative to mean sea level (proxy for aquifer volume / water table) varied by location and through time (Fig. 3). In general, wells in the swales had a positive trend in groundwater depth through time, while wells in more inland areas (north-south within the forest and outside of the forest preserve) had a negative trend in groundwater depth through time. Trends were dominated by a severe drought period near the project start, followed by significant flooding after Hurricane Florence (late 2018 - 2019).
- After discussion with the BHW Monitoring Advisory Group, it was decided to end monthly manual well sampling in June 2023. Monthly data have been shared with ARM for detailed analysis.

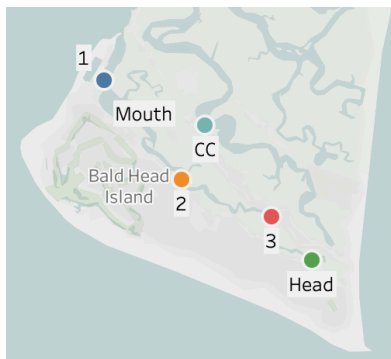
**Fig. 8.** Creek water quality sites. Sites sampled weekly within Bald Head Creek include (downstream to upstream) Sites 1, 2, and 3, and Cape Creek (Site CC, mid-creek). Sites sampled quarterly for 24 hours within Bald Head Creek include “Head” and “Mouth”. “Mouth” is the same as Site 1.

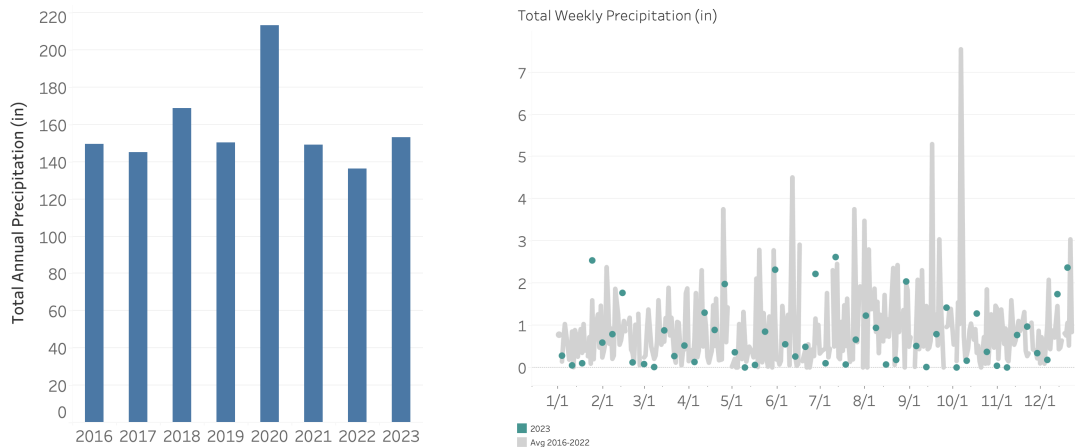
**Fig 9. A.** Total annual precipitation from the Bald Head Island weather station, 2016 - 2023. Note that 2018 is an underestimate due to power loss to the weather station during Hurricane Florence. **B.** Total weekly precipitation by week in 2023 compared to the weekly average, 2016 - 2023.

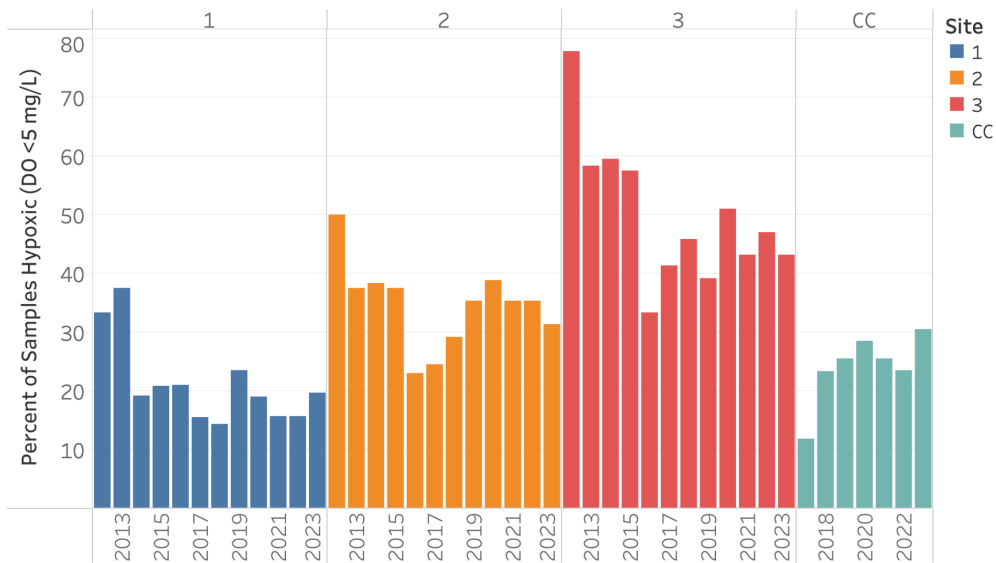
**Fig. 11.** Percentage of dissolved oxygen samples that were characterized as “hypoxic” (< 5 mg/L) for each site and year. Daytime samples were taken weekly, year-round.

- Dissolved oxygen and pH were moderate in 2023 (Fig. 10), however, BHI Creek experienced hypoxia (D.O. < 5 mg/L) for 20 - 40% of samples (Fig. 11). These hypoxic conditions seem characteristic of each site, with upstream sites experiencing more hypoxia than the mouth.

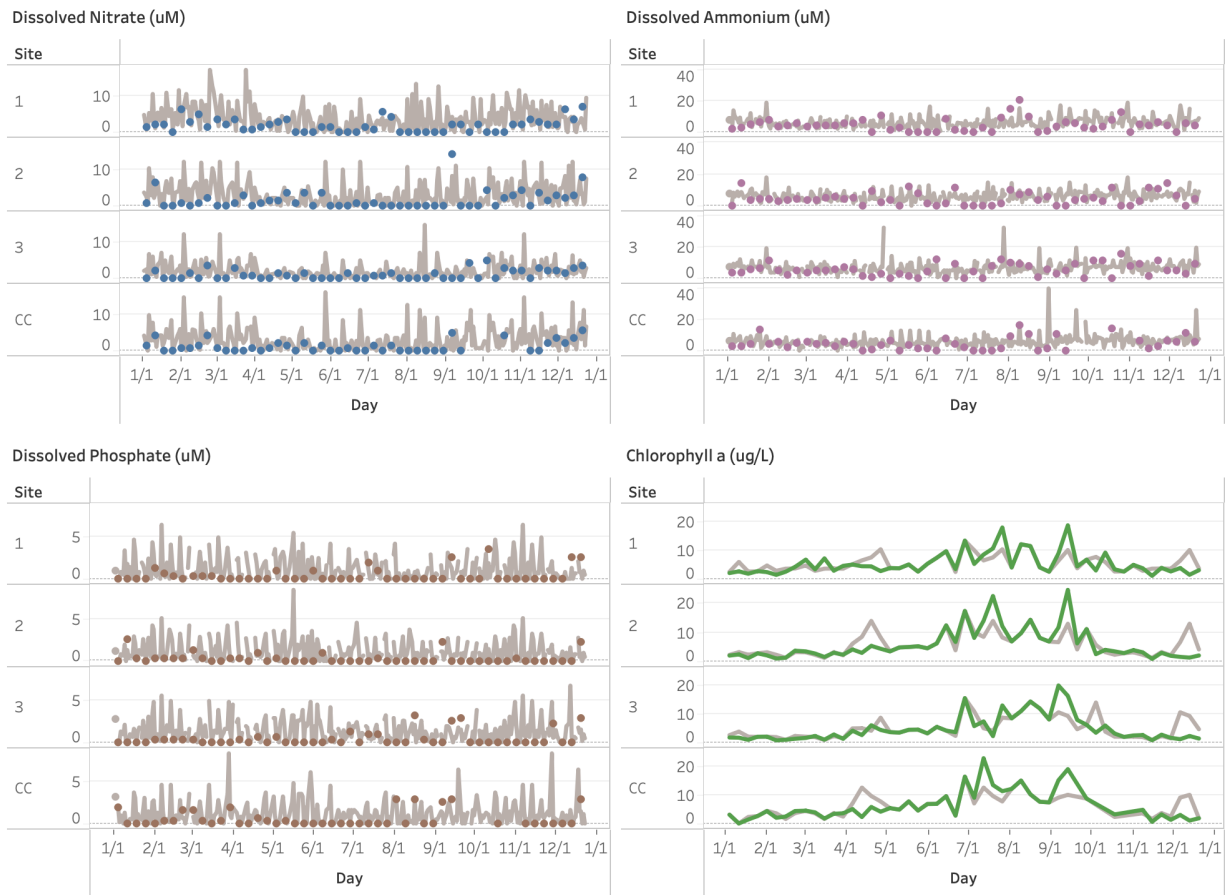
**Fig. 12.** Comparisons of weekly creek water quality sampled in 2023 (colored lines) to the average for 2017-2022 (gray line) for a given site and day of the year. Chlorophyll average was for 2021 - 2022 only.

Nitrate concentration from 9/6/23 at the mid-Creek site (Site 2) was very high (14.29 uM); this was an unusually high value for this time of year. The Creek experienced higher than usual phosphate concentrations throughout all sites at the same time. Fecal indicator bacterium *E. coli* concentrations were not high at Site 2 at this time, but were elevated at Sites 1 and 3. Together, these results indicate a source of nutrients to the creek that may have been wastewater-derived. The following week (9/13/23) all four sites experienced high chlorophyll concentrations consistent with a phytoplankton bloom that may have been stimulated by these high nutrient concentrations.

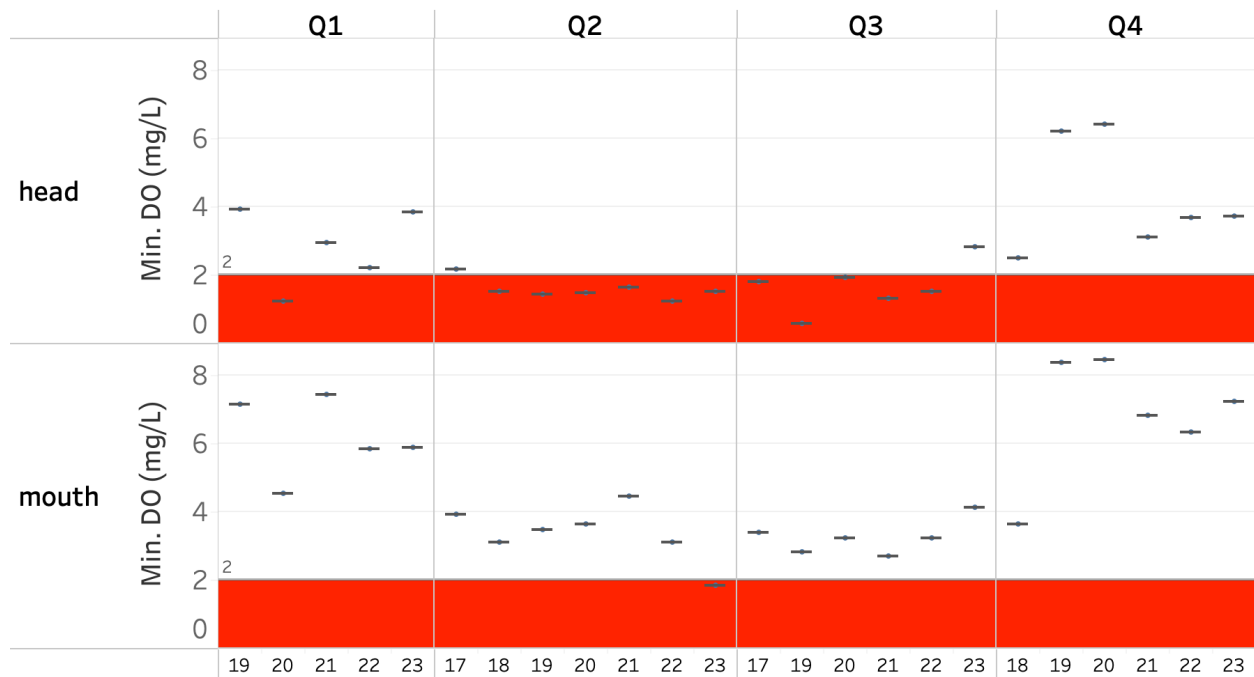
**Fig. 13.** 24-hour creek sampling revealed that water at the Head of the creek has regularly gone anoxic (< 2 mg/L) overnight during Quarters 2 and 3 (June and September). This does not generally happen at the Mouth site, or during Quarters 1 and 4 (March and December).

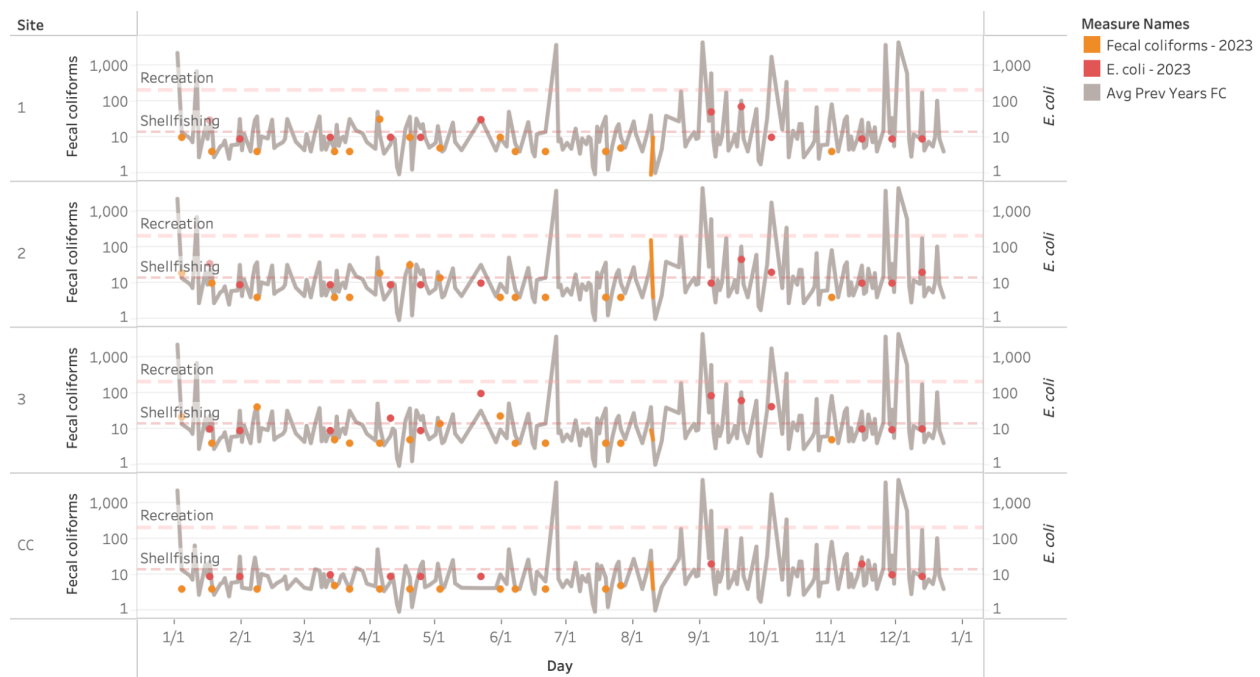
**Fig. 14.** Fecal coliform (orange) and *E. coli* (red) densities were lower than Recreational Water Quality Standard (200 cfu/100 ml) but occasionally higher than the Shellfishing Standard (14 cfu/100 ml).

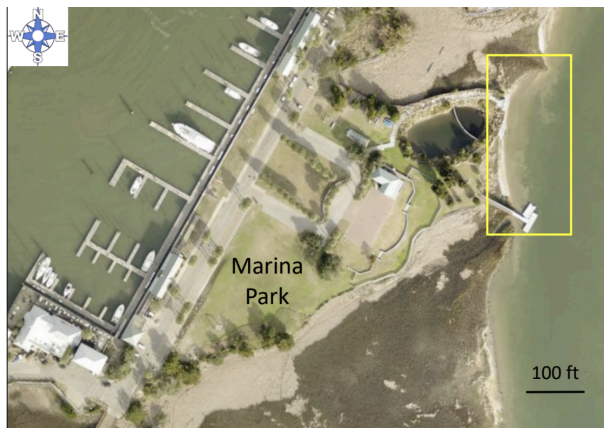
**Fig. 14.** Location for living shoreline at Marina Park.

In spring 2024 it was discovered that the bulkhead behind the proposed living shoreline would need to be replaced. This work would need to be completed before the living shoreline project was installed, so the project was delayed. The bulkhead is expected to be replaced in August 2024, and the living shoreline can be completed in September 2024. Funds for this project were moved to the 2024-25 Environmental Services Contract.

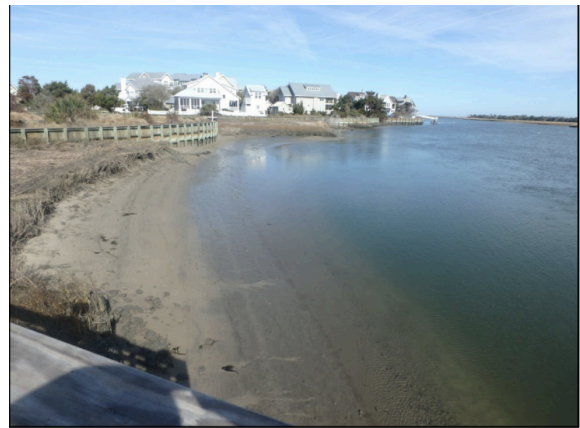
**Fig. 15.** Living shoreline location, facing north.

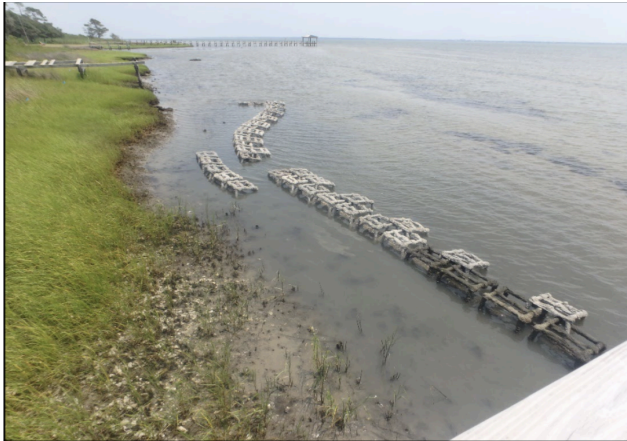
**Fig. 16.** Example project using Oyster Catcher™ substrate

In 2021, BHI Conservancy independently established three small experimental oyster reef restoration sites in Bald Head Creek. These projects were built from bagged oyster shells, and have been monitored yearly for oyster settlement, growth, and habitat for reef-associated fauna. These projects have been largely successful. In 2022, the Conservancy and Village of BHI agreed to partner on a new living shoreline project on Village property at Marina Park, a marsh site near the mouth of Bald Head Creek that has eroded substantially (Figs. 14, 15). The living shoreline at this site would help protect and build the marsh, protect an existing bulkhead, and provide an educational demonstration site for BHI residents and visitors. The Living Shoreline project was added to the 2023-24 Environmental Services Contract, and progress was made to obtain a contractor (SANDBAR Oyster Co.) to complete the work, a work plan, cost-share from the NC Coastal Federation/State of North Carolina, and permitting. The proposed living shoreline sill for Marina Park will consist of an oyster reef sill created within the intertidal zone, using two different shapes of SANDBAR's patented/patent-pending biodegradable hardscape called Oyster Catcher™ (Fig. 16).

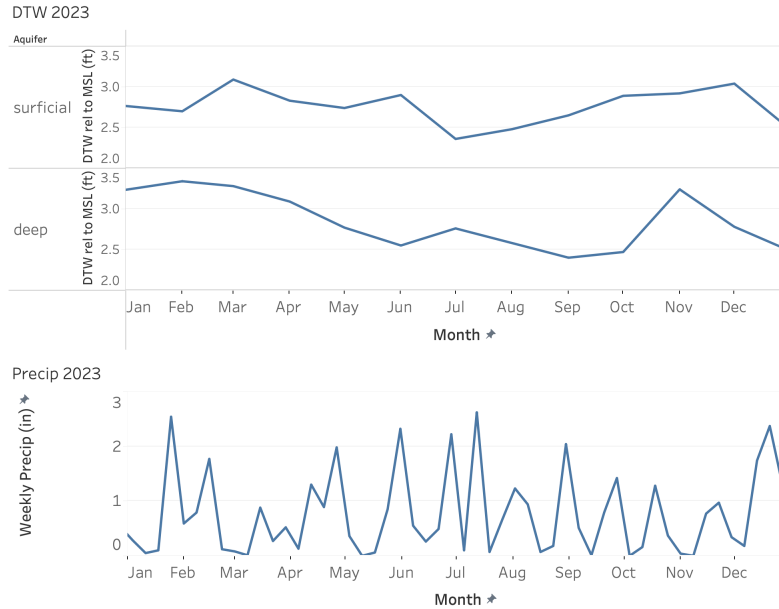
**Fig. 17.** Depth to water relative to mean sea level was lowest in July for wells in the surficial aquifer and September for wells in the deep aquifer. Depth to water relative to mean sea level was highest in late winter-early spring.

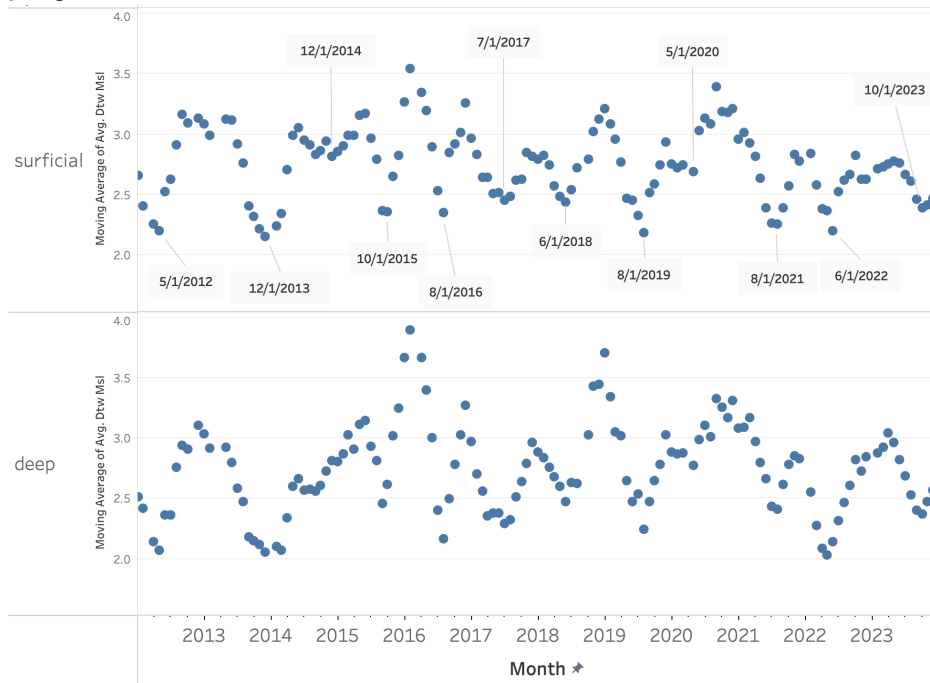
**Fig. 18.** 3-month running averages of groundwater depth to water relative to mean sea level revealed annual maxima and minima in groundwater levels. From 2016 onwards, groundwater minima were in summer, when the island population and water withdrawals were highest.

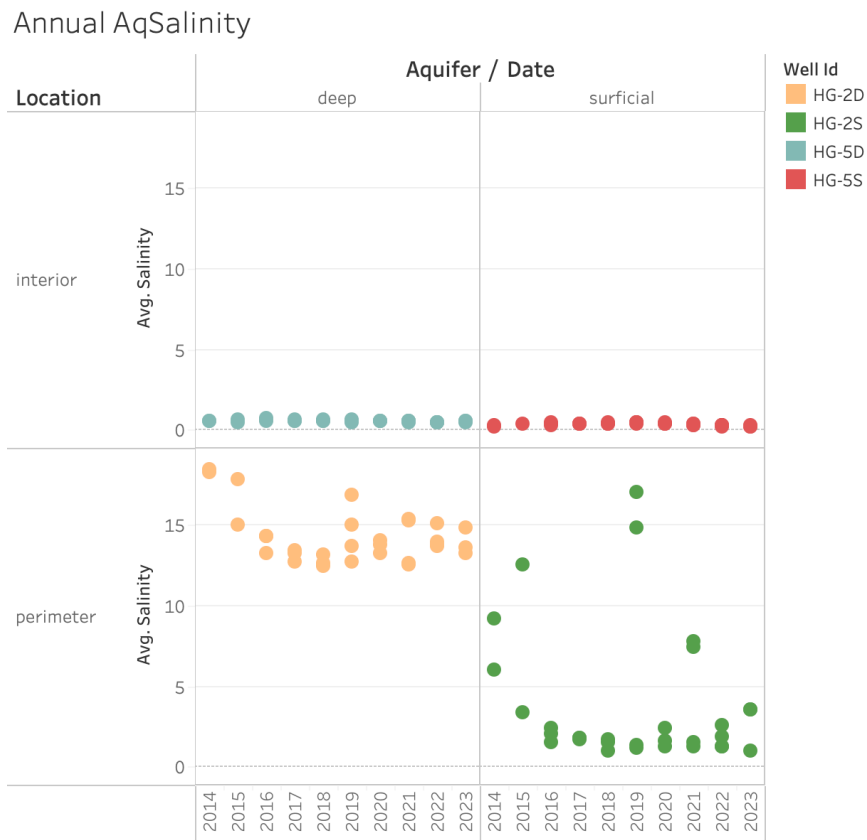
**Fig. 20.** Groundwater salinity by date for example wells from locations at the interior of the island vs. perimeter, and sampling the surficial vs. deep aquifer.

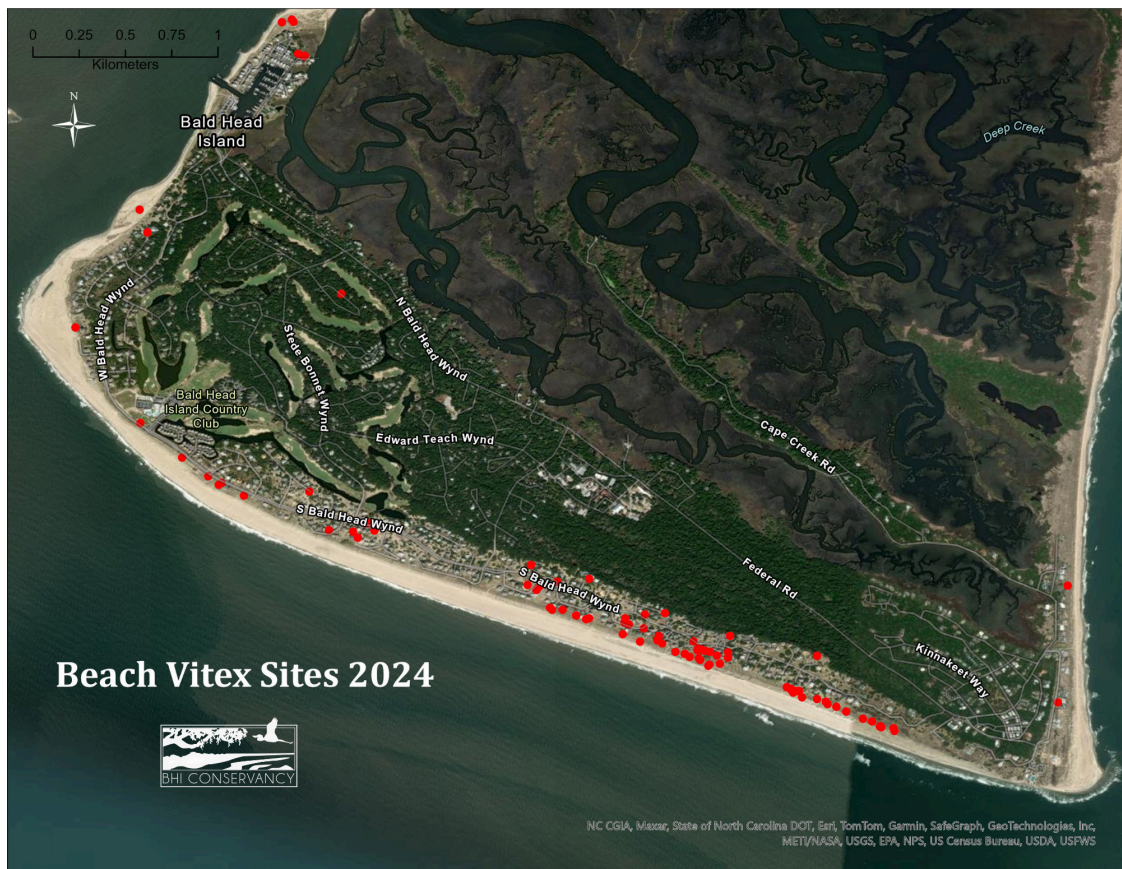
**Fig. 22.** The map shows the remaining active locations of Beach Vitex on the island that are in treatment for next season (Fall 2024). There is a large concentration on SBHW, especially in between Muscadine and BA 34.

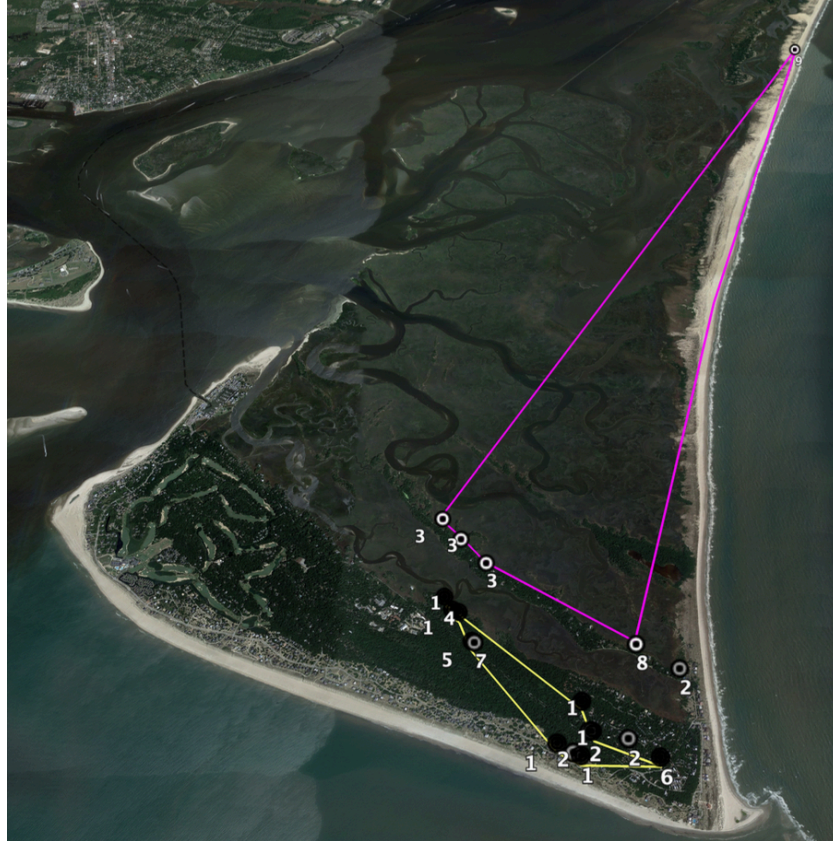
**Fig. 26.** Individual coyotes (numbered 1 - 9) and geographic range of family groups (yellow polygon = Group 1; pink polygon = Group 2). Coyotes 2 (male) and 7 (female) were individuals unrelated to the two family groups.

In fall-winter 2022-23, we worked with Dr. Liz Kierepka from the NC Museum of Natural Sciences to conduct a population study of BHI coyotes using genetic markers from coyote scat. Results revealed the presence of 9 individuals on BHI: 3 female and 6 male. This led to a population estimate of between 8-18 individuals, with 8 individuals on BHI proper and 4 on Middle Island & Ft Fisher (Fig. 26). The genetic data also revealed that there were two family groups (consisting of first-degree relatives): one on BHI and one on Middle Island/Ft Fisher, plus two unrelated individuals. The study confirmed that there is population connectivity between Middle Island and Fort Fisher, meaning that coyotes could use Middle Island as a refuge from Ft Fisher, and/or that individuals could travel from Middle Island to Ft Fisher to fill in a population niche that opens up when trapping occurs.

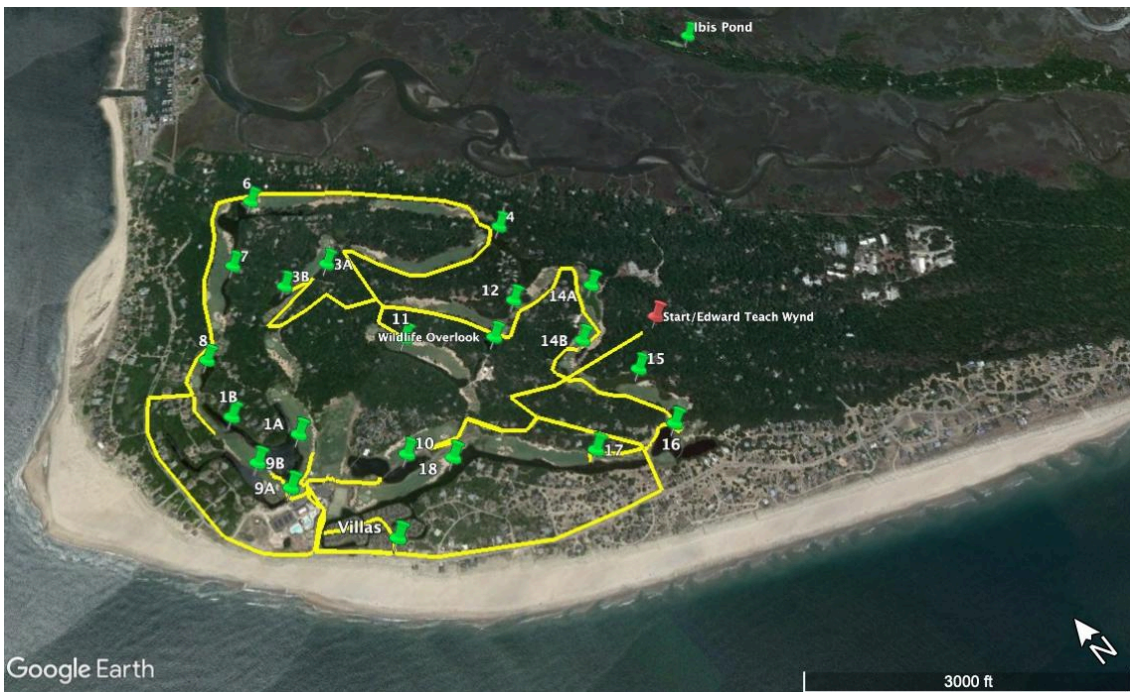
**Fig. 27.** Alligator spotlight survey route, summer 2023.

In summer 2023, we conducted 12 nighttime alligator surveys. Our survey area included all BHI Club Golf Course ponds, Ibis Sanctuary Pond, Villas, and the Wildlife Overlook (Fig. 24). The average number of observed alligators viewed nightly in 2023 was 33 per night. Notably, Hole 15 had one large alligator (7-10 ft, who we believe is the mother, "Mama") and about 21 smaller alligators (1-3 ft) observed during almost every survey. In spring 2022, the Conservancy collaborated with the Belcher Lab from NC State University to conduct alligator satellite tagging to further understand the locations and movements of alligators and advise public safety

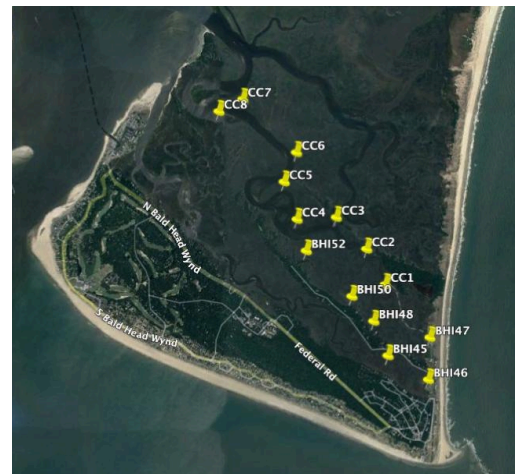
**B.** Black Rail sampling sites on BHI

Black Rails are a secretive marsh bird that hypothetically could be found in high marsh habitats on BHI, and because of their preferred habitat, they are at special risk from sea level rise. The state of North Carolina has begun conducting callback surveys for black rail and encouraged BHI to conduct these surveys because of the existence of appropriate habitat for this species on the island. If black rails were detected on BHI, this would be a big news story for our area! We conducted callback surveys three times during nesting season in 2022 and 2023. No Black Rails were detected in 2022 or 2023 surveys, although we did hear Clapper rails on our surveys.

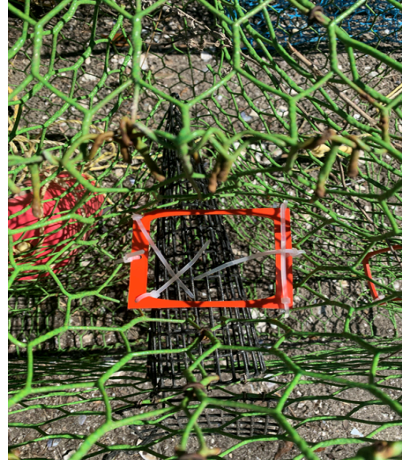
**Fig. 35.** Terrapin excluder device (TED) on crabpot.

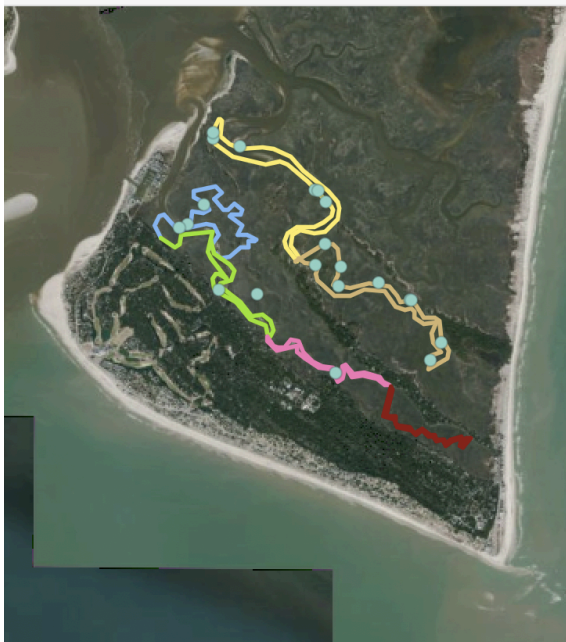
**Fig. 36.** Terrapin Tally survey routes, spring 2023. Dots are diamondback terrapin sightings.

- Kayak surveys for diamondback terrapins were conducted in May-June 2023 as part of SE NC Terrapin Tallies organized by the NC Coastal Reserve. Six routes in Bald Head Creek and Cape Creek were paddled by 25 individuals (16 Conservancy staff and 9 volunteers) 2-5 times each. 28 diamondback terrapins were spotted on BHI during Terrapin Tallies, in both Bald Head Creek and Cape Creek, with the majority of terrapins sighted in the upstream waters of Cape Creek (43%).
- BHI Conservancy responded to one live terrapin stranding in April and one dead terrapin 7/24/23
- Over 100 Terrapin Excluder Devices for crabpots were given out to the public. We held 4 workshops teaching about terrapin conservation and assisting owners of crabpots with installing TEDs.
